Effect of Surface Cleanliness on Powder Coating Quality

Abstract

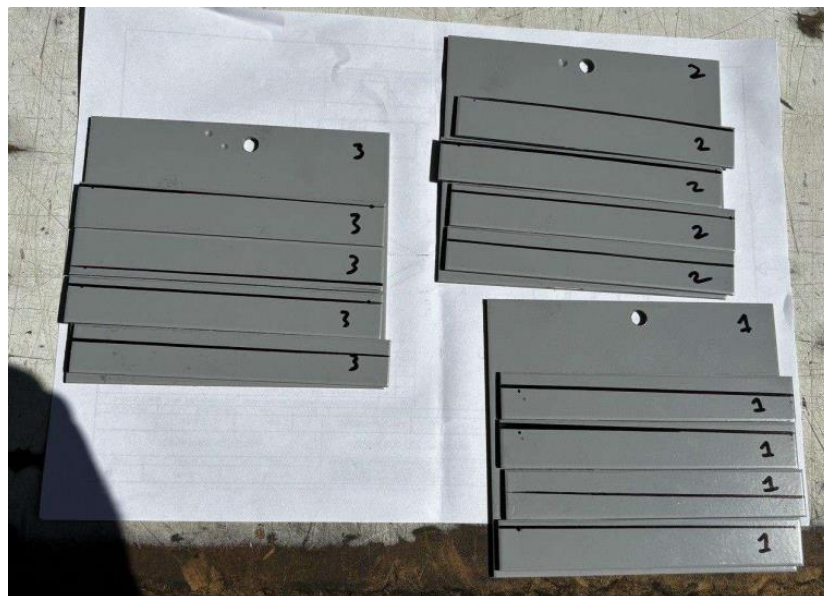
Figure 6. Sheet metal parts cut and marked for testing

All these parts, which were cleaned in three different ways, were consecutively placed together into the powder coating booth and coated with electrostatic powder paint. Then, with the help of the conveyor, they continued into the paint curing oven and were held for the duration of the curing process. After the curing process was completed, the parts were removed from the oven and let cool. Afterwards, they were cut into 18mm sheets and marked, as seen in the Figure 6.

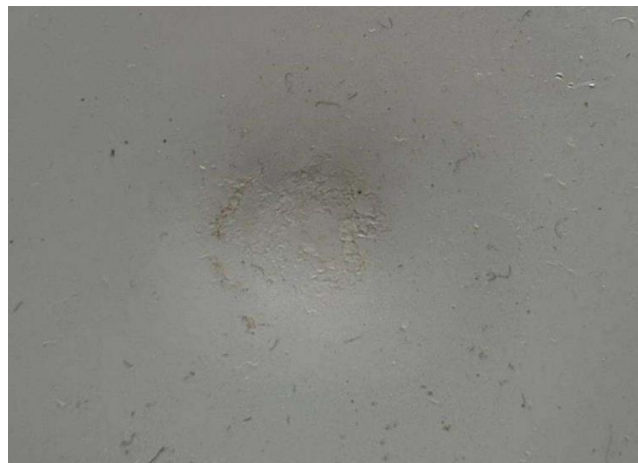
The results for the impact test can be analyzed visually. In the sample cleaned in the washing line, a small amount of deformation is observed on the paint surface. This deformation can be interpreted as resulting from the sheet metal itself being deformed, causing the paint on the surface to be compressed and damaged. However, no visible paint detachment or blistering is present after the impact, as seen in Figure 7.

Figure 7. Sample cleaned in washing line, after the impact test

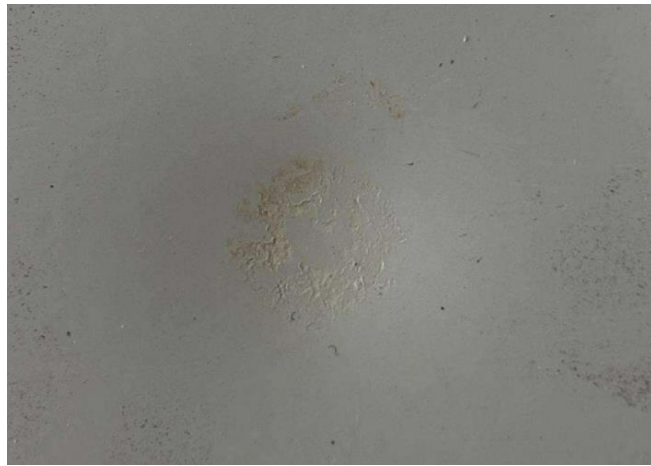
In the sample wiped with thinner, a minimal yet more noticeable amount of paint deformation is observed compared to the sample that passed through the washing line. This can be interpreted as a result of the paint's adhesion quality to the material being slightly lower in this sample compared to the washed sample as it can be seen in Figure 8.

Figure 8. Sample wiped with paint thinner, after the impact test

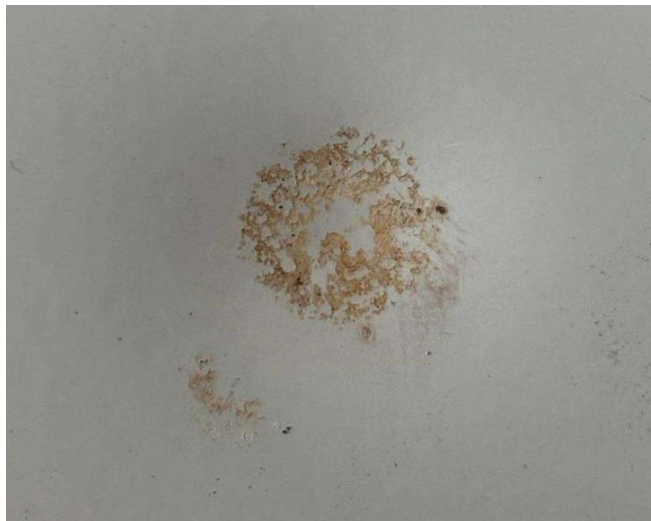
In the untreated sample, areas of paint detachment and the marks left by the impact are clearly visible. Compared to the other two samples, this one shows the highest amount of paint detachment and the most visible marking. This is thought to be due to the paint not adhering properly to the sheet metal, resulting in the paint peeling off after the impact as it can be seen in Figure 9.

Figure 8. Untreated sample, after the impact test

After the impact test, it was generally observed that as the surface cleaning quality of the parts decreased, the rate of paint peeling due to impact increased. Although the sample wiped with thinner showed less peeling compared to the untreated sample, the paint on the surface of the sample that passed through the washing line showed the best overall performance. Based on this result, it has been demonstrated that wiping with thinner before electrostatic powder coating provides better impact resistance than coating without any cleaning process, while cleaning through a washing line results in the highest resistance.

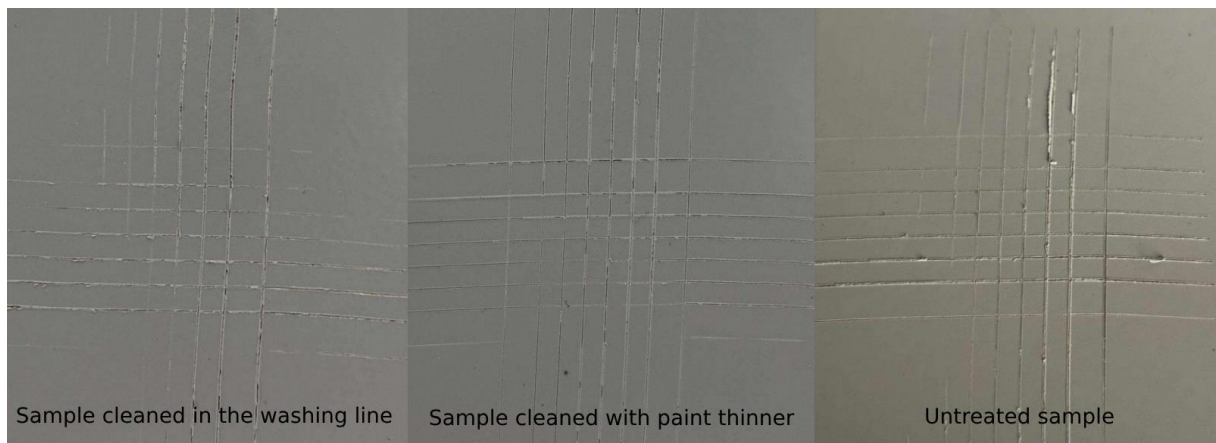
As a result of the cross-cut test, every sample yielded a level 0 result in accordance with ISO 2409 standard, which means that there was no paint removal from any of them. Following this test, it was observed that all three samples successfully passed. Therefore, no suitable data could be obtained to compare the effect of surface cleaning prior to painting on paint quality based on this test. The results can be seen in Figure 9.

Figure 9. From left to right: Washing line sample, paint thinner sample, and untreated sample cross-cut test results

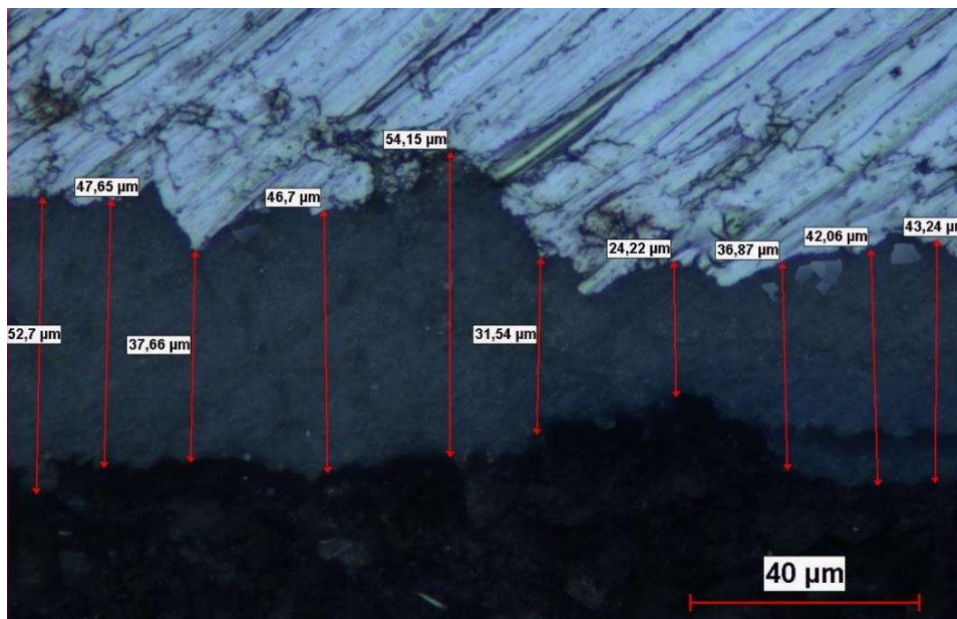
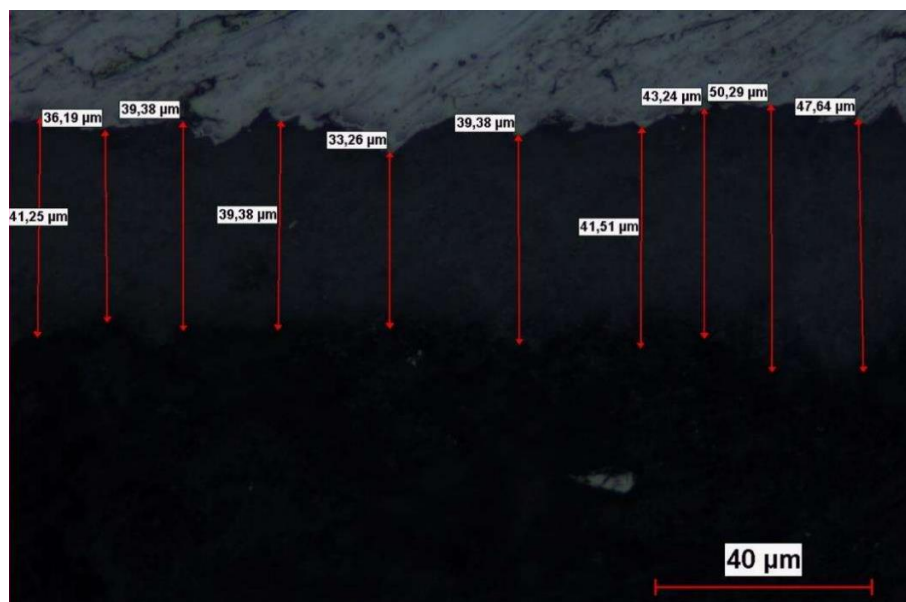
For each sample’s cross-sectional image examined under the microscope, images were taken from random areas of the three sections embedded in bakelite. In each captured image, 10 measurements were taken to determine the average paint thickness. All images are captured in 500x magnification unless stated otherwise. Some of the captured images with the measurements are presented in Figure 10 to Figure 15.

Figure 10. Washing line sample, measurement 1

Figure 11. Washing line sample measurement 2

As seen in Table 1, the average paint thickness remains consistent across all the measurements, with moderate standard deviation. This suggests that the samples that went through a washing line have a relatively consistent thickness in the paint layer.

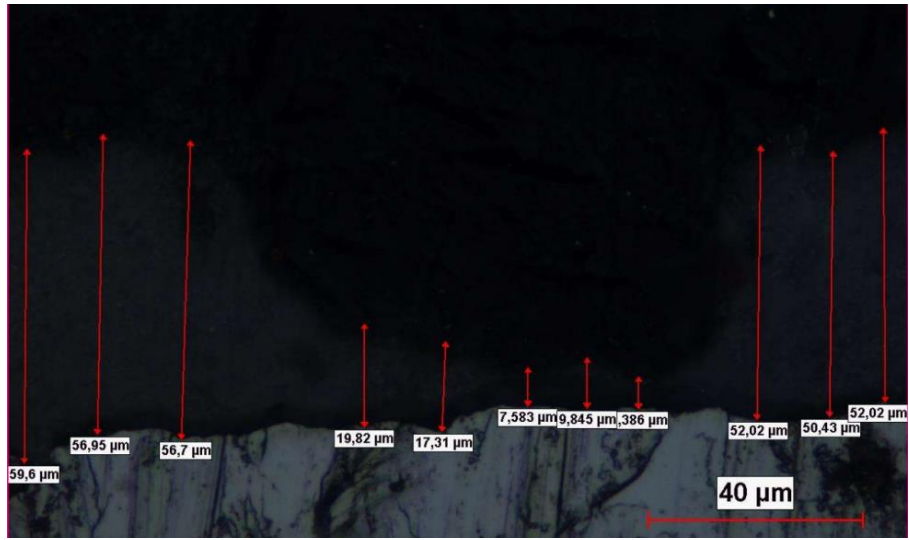
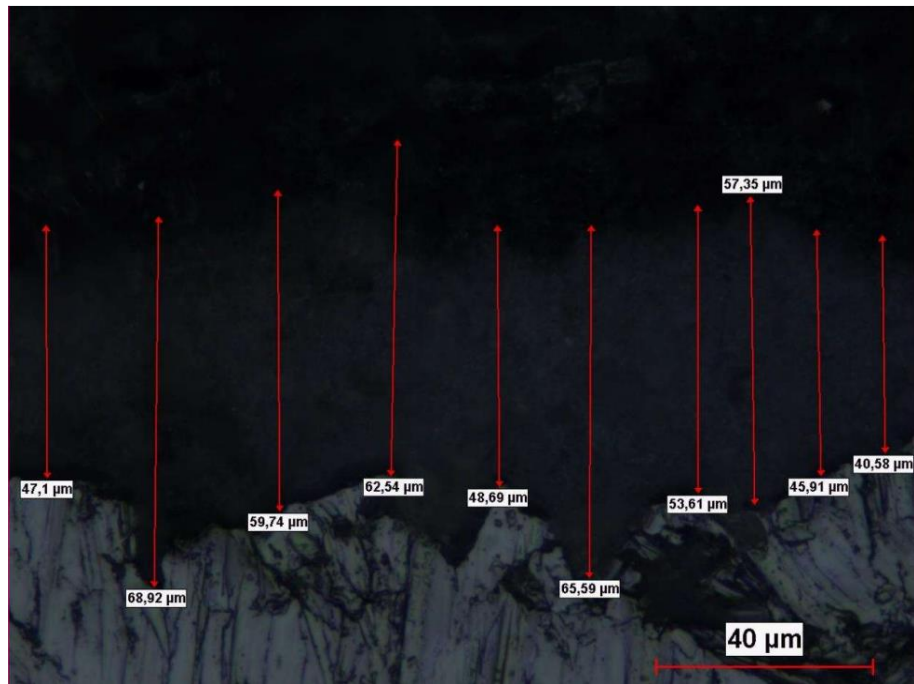
Figure 12. Paint thinner sample, measurement 1

Figure 13. Paint thinner sample, measurement 2

Table 2 shows that the average paint thickness is generally higher than the values from Table 1, the variation is more noticeable, with standard deviation values up to 21.34. This implies that wiping the samples with paint thinner may lead to a less consistent coat compared to the washing line samples, due to the possibility of missing certain spots in the cleaning process by hand. The greater overall thickness values may be due to residue between the surface and the metal.

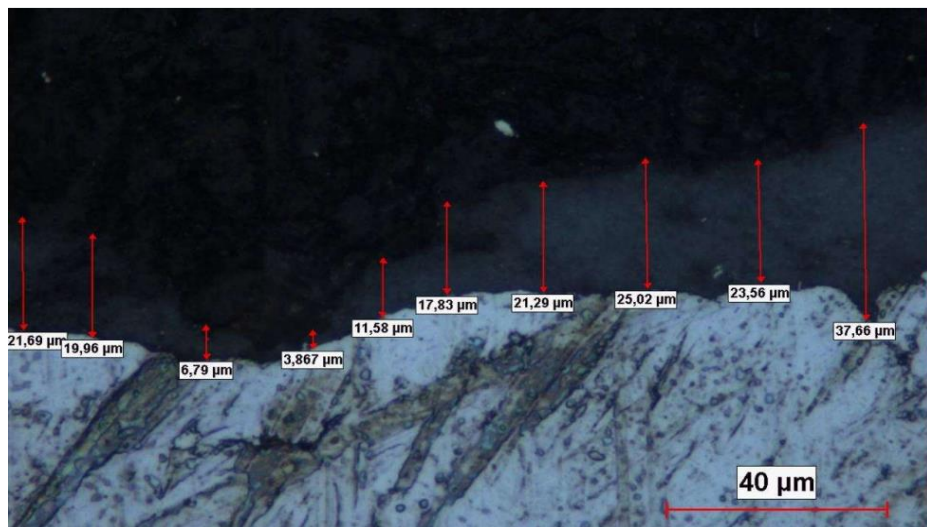
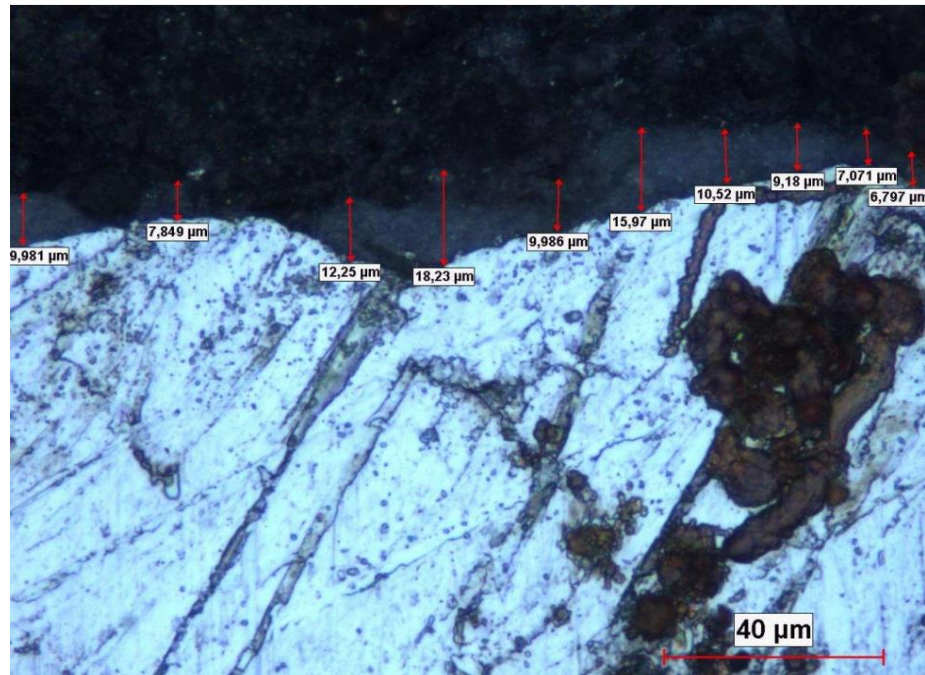
Figure 14. Untreated sample, measurement 1

Figure 15. Untreated sample, measurement 2

According to Table 3, the average paint thickness significantly less than the other two samples in most measurements, and the standard deviation is moderate to high. These results show that the untreated samples have a much thinner paint layer that can lead to less resistance to corrosion and impact.

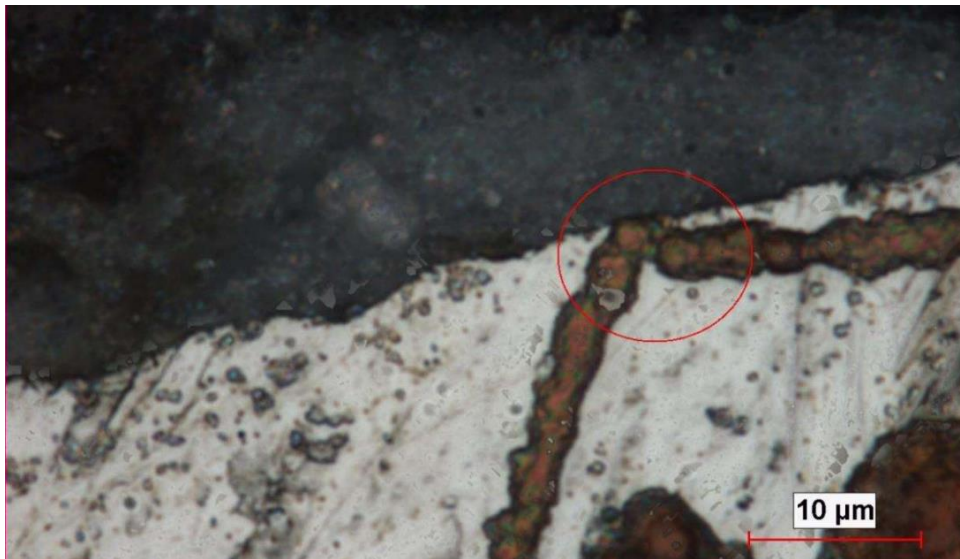
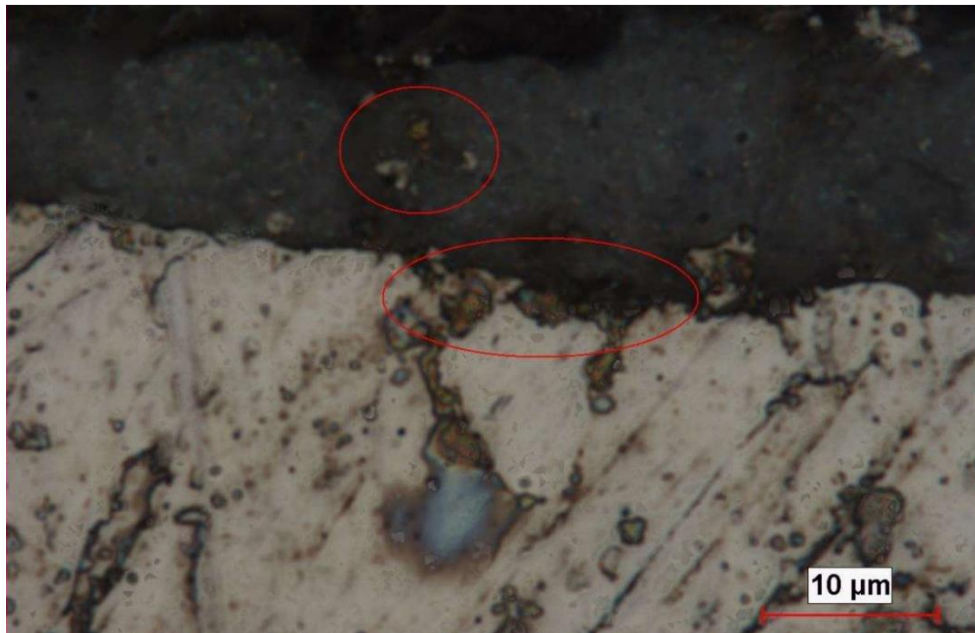
Residual substances are observed between the material and the paint in the untreated samples. Such residues both reduce the adhesion quality of the paint, as seen in the impact test, and lead to a decrease in paint thickness and a non-uniform coating causing extremely thick or extremely thin coating layers. This can be seen in Figure 16 and Figure 17 below.

Figure 16. Residual substances between the metal surface and the paint for the untreated sample

Figure 17. Residual substances between the metal surface and the paint for the untreated sample
